# *Continuous digester rapid thinning and general corrosion*

MARGARET GOROG

**ABSTRACT:** Carbon steel continuous digesters built after the early 1980s are fully stress relieved, so stress corrosion cracking has been less of a concern. However, these newer digesters were designed to run modified cooking processes that have turned out to be much more corrosive than those running with conventional cooking. This corrosion is mainly associated with softwood digesters and appears to be flow related. Average corrosion rates of 40 mil/year are possible on the exposed shell between the wash and extraction screens. The corrosion patterns are visually distinct from surfaces in the upper digester and below the wash screens.

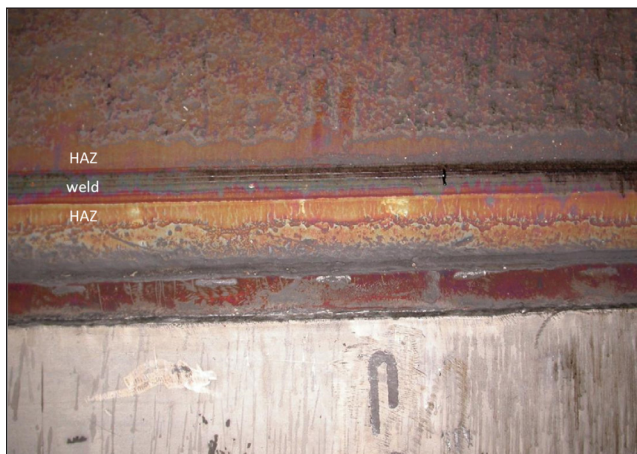
**3. Preferential corrosion of a weld and heat affected zone.** Rapid thinning can display a variety of colors.

Rapid thinning manifests itself in several different ways that distinguish it completely from corrosion seen in passive locations. Preferential corrosion is common, as shown in **Fig. 3**. Weld caps corrode away, leaving them ditched out below the plate surface. Heat affected zones, grind

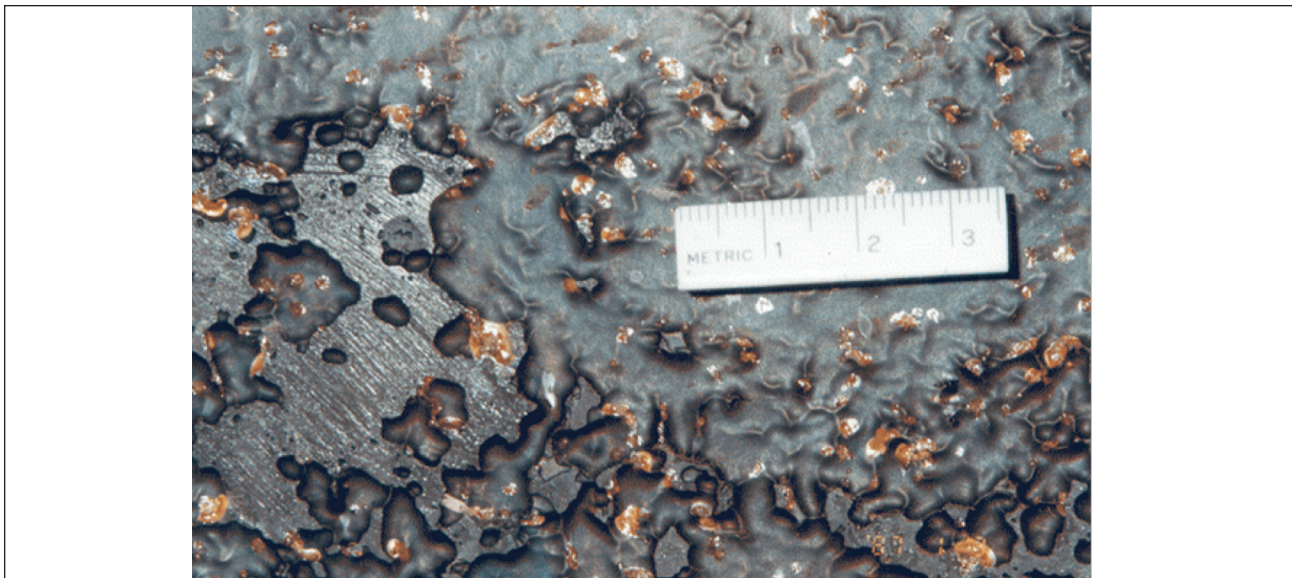
4. "Ocean-island" corrosion. Low areas drop off steeply from the high areas.

As to widespread corrosion, there are two main features. The first may be called "ocean-island" corrosion where small islands of metal protrude sharply, almost at right angles, above the lower ocean floor, as **Fig. 4** and **Fig. 5** display. The islands possibly consist of microchemistries that may be more resistant than the widespread ocean areas. The floor is smooth, a sign that flow is a factor. Colors may vary and for the most part, the corroded surfaces are not rust red.

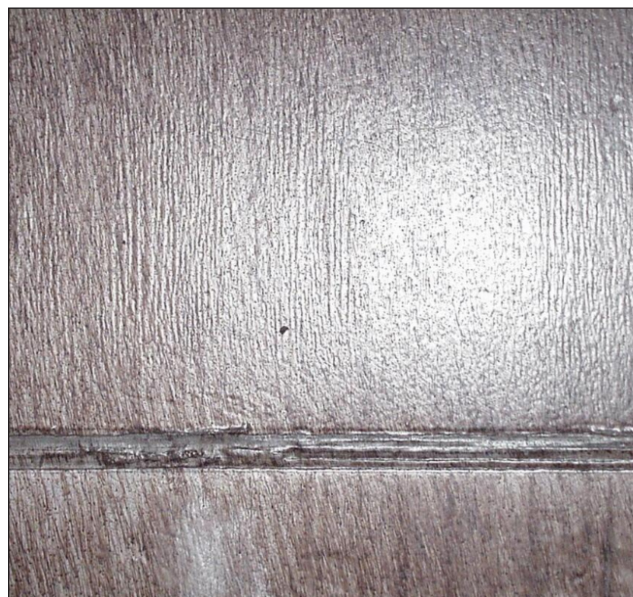
6. Grooving on the corroded surface suggests a form of erosion-corrosion. Preferential corrosion of the weld is also occurring.

present but any round liquor pitting is washed out. These surfaces appear to be shiny and can be light grey in color, as seen in **Fig. 6**.
