# *Using multi-method analysis to identify challenging paper machine deposits and defects*

**ABSTRACT:** Based on its speed and versatility, Fourier transform infrared (FTIR) spectroscopy is the industry's common starting point for analysis of a paper machine deposit or defect sample. However, certain contaminants and papermaking process additives cannot be precisely identified solely by infrared spectral interpretation. This lack of specificity could lead to a misinterpretation of the composition of the deposit or defect.

**Application:** This paper discusses how the use of multiple analytical techniques can work in concert to help troubleshoot challenging paper machine deposits and defects.

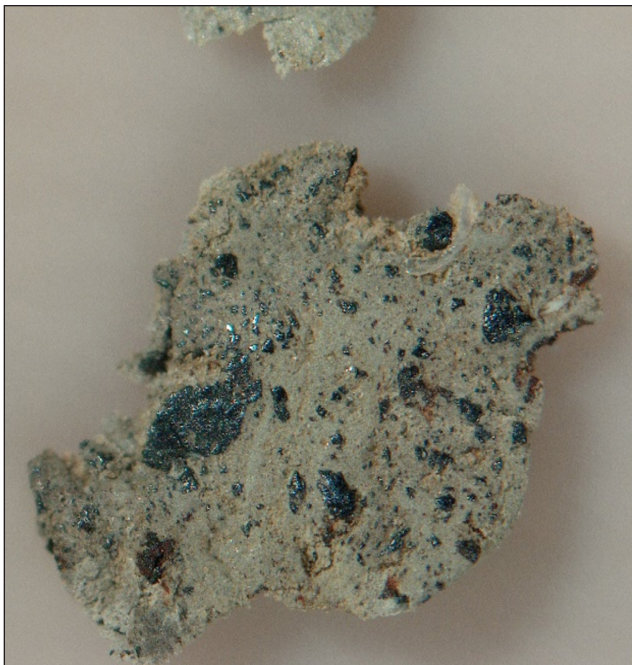
**7. Doctor blade debris collected during a mill outage.**

Doctor blade debris was collected from the mill's primary machine during an unscheduled outage. The mill had previously experienced a temporary, but severe, stickies outbreak, and the machine superintendent wanted to determine whether the current deposition was related to a stickies re-occurrence or something else. A digital image of the doctor blade debris was acquired and is displayed in **Fig. 7**.

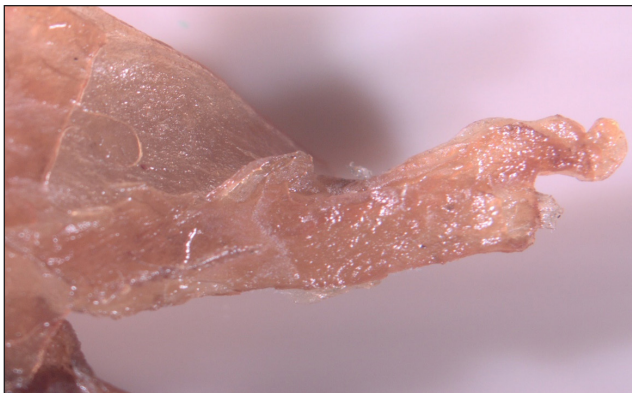
**11. Gelatinous deposition found during the cleaning of a whitewater chest.**

Our final case study involves gelatinous, amber-colored deposition that was found in a whitewater chest and was believed to be the cause of recent sheet breaks. Whether the deposition was related to microbiological activity or whether it was related to a wet-strength resin trial the mill had recently run was unknown. A digital image of the deposition was acquired and is shown in **Fig. 11**. The initial as-is IR analysis results of the oven dried whitewater deposition are displayed in **Fig. 12**, along with reference spectra of polyamide-based microbiological activity, polyamide-based wet strength resin, and cellulose fiber.
